Spot Safety Project Evaluation

Project Log # 200508007
Spot Safety Project # 13-97-007

**Spot Safety Project Evaluation, of the Traffic Signal Installation,
At the Intersection of US 25-Hendersonville Road and I-40 Eastbound Off Ramp,
In Asheville, Buncombe County**

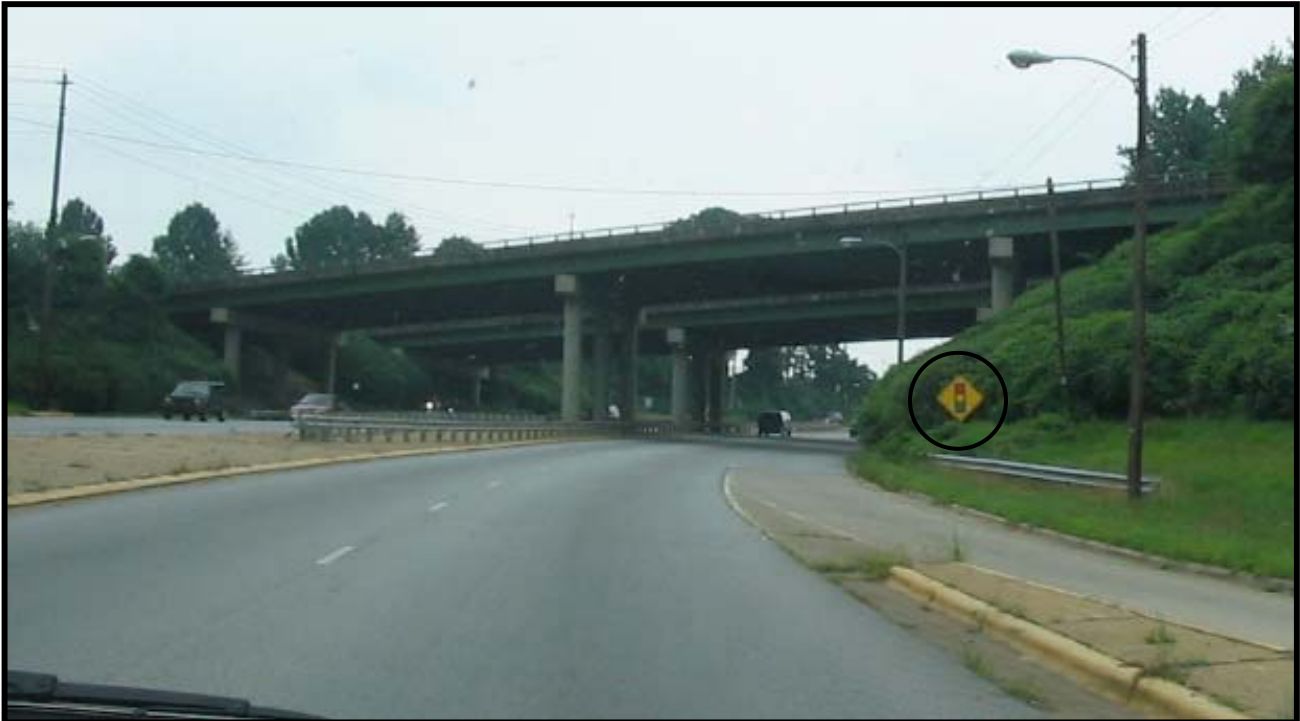
Driving southbound on US 25-Hendersonville Road towards the Treatment Intersection.
Notice the Signal Ahead Warning Sign.

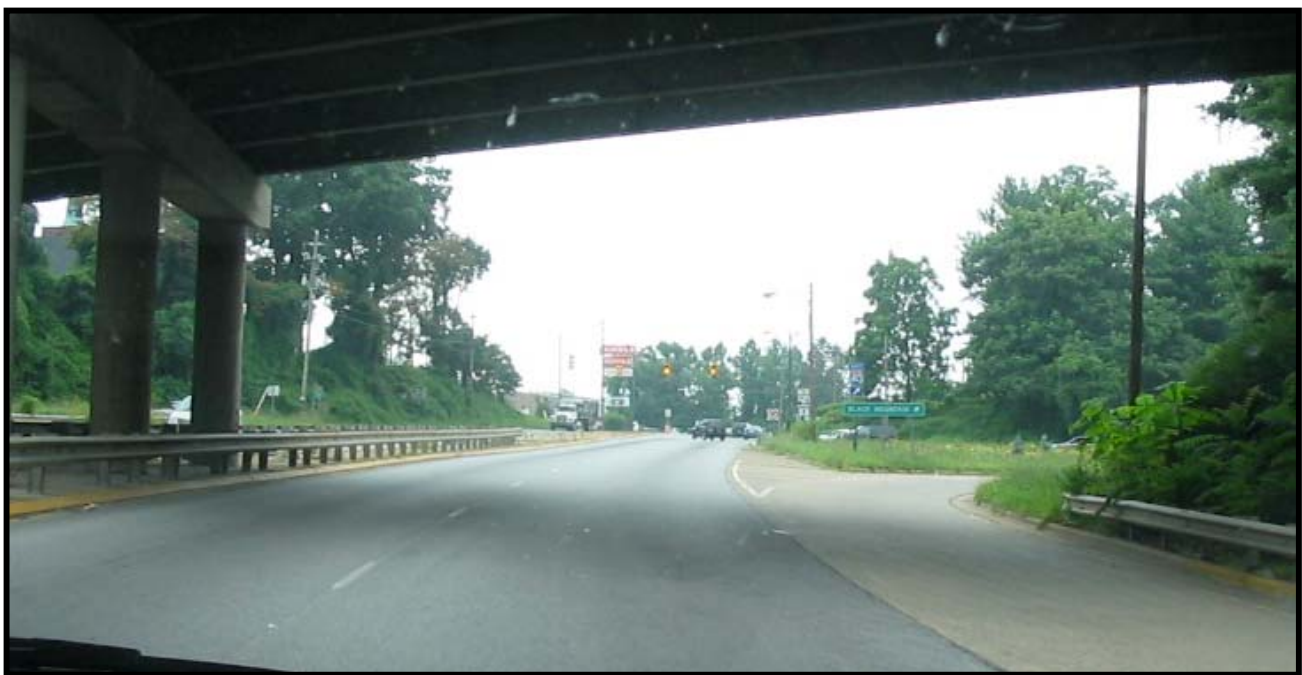
Driving southbound on US 25-Hendersonville Road approaching the Treatment Intersection.

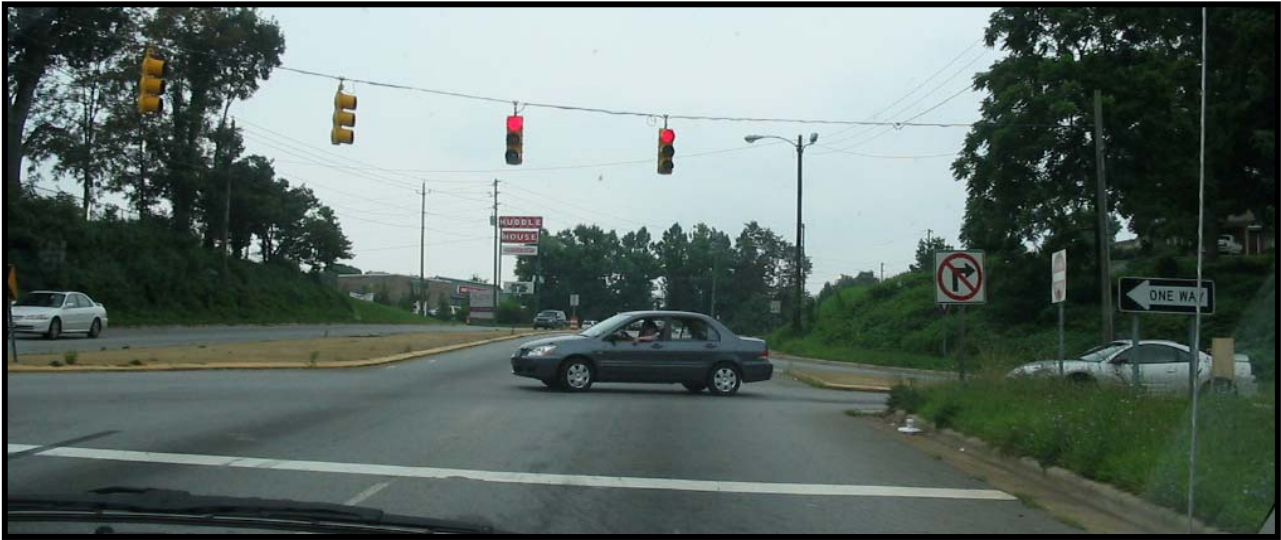
Driving southbound on US 25-Hendersonville Road stopped at the Treatment Intersection.

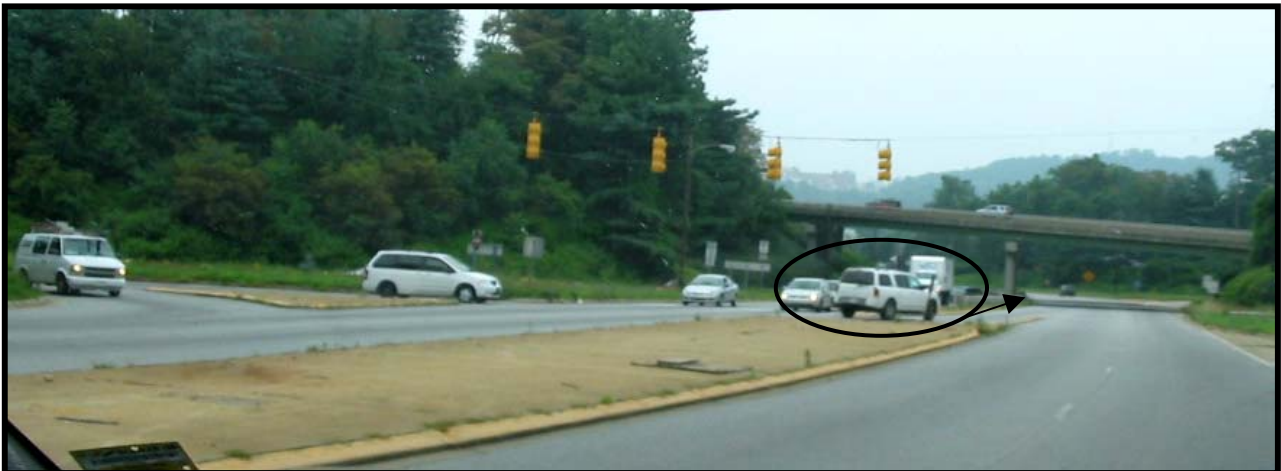
Driving northbound on US 25-Hendersonville Road towards the Treatment Intersection.
Notice the vehicle above getting ready to merge with the northbound travel lanes.
